**Flood Control Project Maintenance
Levee Inspections**

Fall 2018 Levee Maintenance Deficiency Summary Report

**Flood Control Project Maintenance
Levee Inspections****LMA District Cover Sheet
Fall 2018 Levee Inspection Results****Sacramento River West Side Levee District**

Sacramento River West Side Levee District

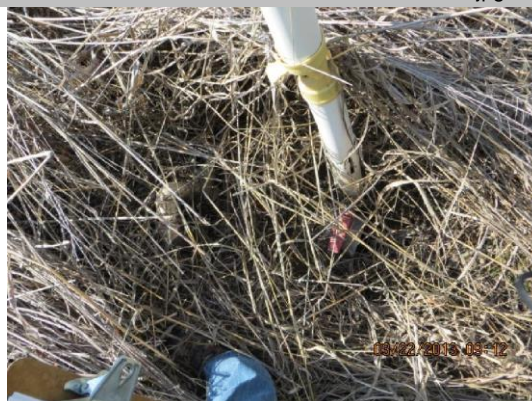
Photo 2 of 3 : UCIP_FA_2018_46812_17908.jpg

Item	DWR UCIP Field Study			39.187497°	39.187497°	
				-121.962074°	-121.962074°	
DWR ID	20314					
Comment Code						
Inspector Comment						
FS_ID:46812 DS_ID:20314 EP_NO: 15763 Repair Type: Non-Urgent Crossing Status: Found UCIP Comments: Fresno valve on WS shoulder is broken. Pipe appears to be abandoned. Need to abandon properly if necessary. site visit on 10/09/2015 indicates water is present somewhere along the waterside levee slope. Possibly siphon breaker or fresno valve sprays and drains down levee slope from WS shoulder. internal inspection of pipe recommended to determine source of leak. Pipe is active, but can be removed and capped when not in use. FIELD_STRUCT_DESC: 4-inch galvanized steel irrigation pipe through the levee, 2 feet below the crown. Irrigation valve approximately 50 feet landward of the landside (LS) toe. Fresno valve on the waterside (WS) shoulder with connection for pump at the WS berm. (Permit No. 15763, 1991 - Randy Salverson). FS Date: 3/22/2013

Pipe connection at WS toe.

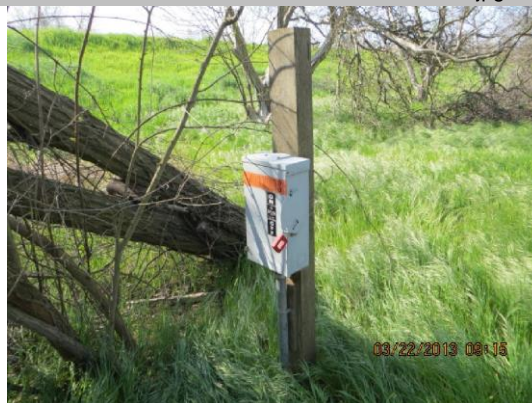
Photo 3 of 3 : UCIP_FA_2018_46812_17907.jpg

Electrical box at WS berm for portable pump.

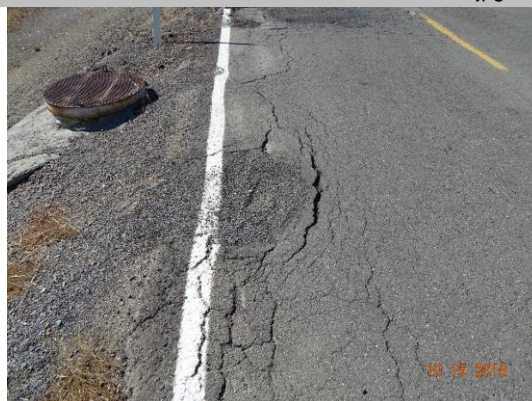
Photo 1 of 3 : UCIP_FA_2018_53020_78180.jpg

UCIP Comments: 10/15/2018 Multiple cracks and points of depression on levee crown pavement (Moon Bend Rd). Sink hole on LS shoulder next to CMP riser. Voids around lower part of CMP riser concrete pad on LS shoulder. Condition of this crossing has worsen since last inspection. Recommend internal pipe inspection to determine pipe integrity through levee. (O.Yakimov - DWR)09/23/2016 - A second pipe is visible adjacent to the intake pipe. According to the permit drawings, this pipe is an access pipe for a submersible pump used to clean the fish screen by backwashing. hole on LS shoulder of the levee and Moon Bend Rd. has been patched. No additional road damage is visible. (T. Hatch/UCIP) 09/01/2016 no visible changes from previous inspection. - (T. Hatch/UCIP) 10/09/2015 Possible sink hole along alignment 10-feet LS of siphon breaker on LS slope. Recent road repair along the approximate pipe alignment suggests that levee slumping is related to pipe. It is recommended that further investigation e.g. video inspection or other internal method may help determine if the issue is due to pipe or due to levee settlement in vicinity of the pipe. (T. Hatch/UCIP)

FIELD_STRUCT_DESC: 18-inch steel irrigation pipe through the levee, 3 feet below the crown. Pump mounted on a piling structure on the waterside (WS) bank. Switch box on the WS shoulder. Siphon breaker inside a 30-inch corrugated metal riser unit on the landside (LS) shoulder. Pipe discharges into a concrete box at the LS toe. (Automatic Board Order (ABO) issued as Permit No. 9349, 1974 - Ramona Davis). (Pump and pump platform replaced under Permit No. 5551, 1966 - Ramona Davis). (Fish screen installed under Permit No. 17222, 2000 - A&L Rental and Leasing). [Additional Reference(s): DWR Levee Log, 2006].

Multiple cracks and poits of depression on levee crown.

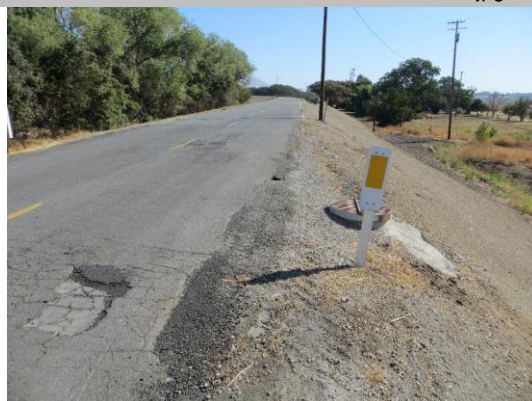
Photo 2 of 3 : UCIP_FA_2018_53020_74723.jpg

UCIP Comments: 10/15/2018 Multiple cracks and points of depression on levee crown pavement (Moon Bend Rd). Sink hole on LS shoulder next to CMP riser. Voids around lower part of CMP riser concrete pad on LS shoulder. Condition of this crossing has worsen since last inspection. Recommend internal pipe inspection to determine pipe integrity through levee. (O.Yakimov - DWR)09/23/2016 - A second pipe is visible adjacent to the intake pipe. According to the permit drawings, this pipe is an access pipe for a submersible pump used to clean the fish screen by backwashing. hole on LS shoulder of the levee and Moon Bend Rd. has been patched. No additional road damage is visible. (T. Hatch/UCIP) 09/01/2016 no visible changes from previous inspection. - (T. Hatch/UCIP) 10/09/2015 Possible sink hole along alignment 10-feet LS of siphon breaker on LS slope. Recent road repair along the approximate pipe alignment suggests that levee slumping is related to pipe. It is recommended that further investigation e.g. video inspection or other internal method may help determine if the issue is due to pipe or due to levee settlement in vicinity of the pipe. (T. Hatch/UCIP)

Siphon Breaker in 20-inch CMP riser on LS Shoulder. Photo taken from LS looking DS along Moon Bend Rd

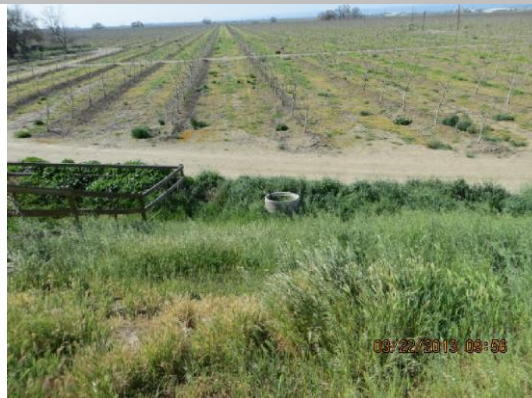
Photo 1 of 1 : UCIP_FA_2018_10553_17929.jpg

Comment Code						
Inspector Comment						
FS_ID:10553						
DS_ID:20298						
EP_NO: 9347						
Repair Type: Non-Urgent						
Crossing Status: Indicator Found						
UCIP Comments: Need to verify type of abandonment.						
FIELD_STRUCT_DESC: 1 of 2: 24-inch irrigation pipe of an unknown material through the levee, 25.5 feet below the crown. 14-inch pipe sleeved through 24-inch pipe. Annular space grouted. Pump inside pump house on the landside (LS). Gate valve inside pump house on the LS. (Automatic Board Order (ABO) issued as Permit No. 9347, 1974 - Floremon Orchards). [Additional Reference(s): DWR Levee Log, 2006. USACE Sacramento O&M Manual 131, May 1960 (HLM 47.71)].						
FS Date: 3/22/2013

Possible location for pipe crossing.

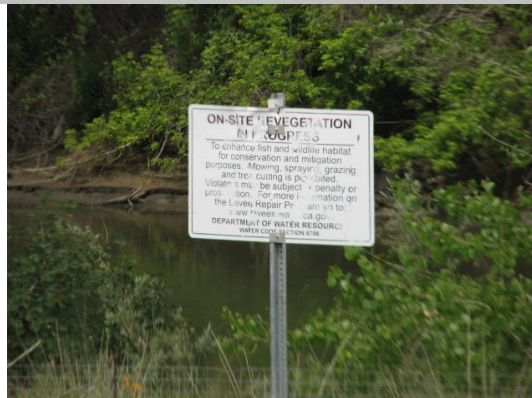
Photo 1 of 1 : FA_2018_NA0016_435_90_20180904_00021.jpg

LM Start	47.19	Rating **	A/W	Issue No.	90
LM End	47.62	Issue Type +	Ob	Location *	WS
Category	Earthen Levee			GPS Latitude/Longitude	
				Start	End
Item	Vegetation			39.189930 °	39.193491 °
				-121.982143 °	-121.988184 °
DWR ID	DWR_NA0016_01_s_2014_90				
Comment Code					
V8 : Environmental Requirements.					
Inspector Comment

A revegetation site along the waterside berm. Spring 2014

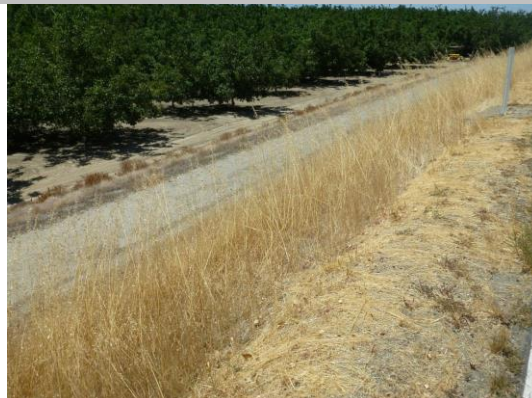
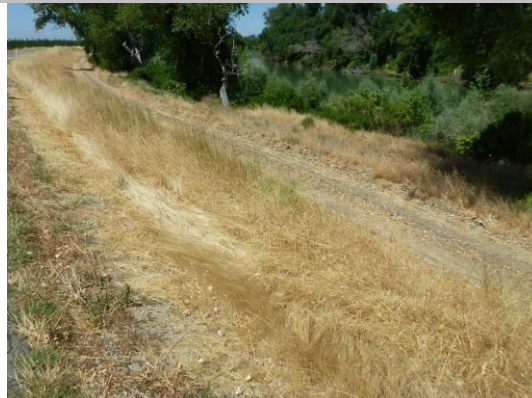
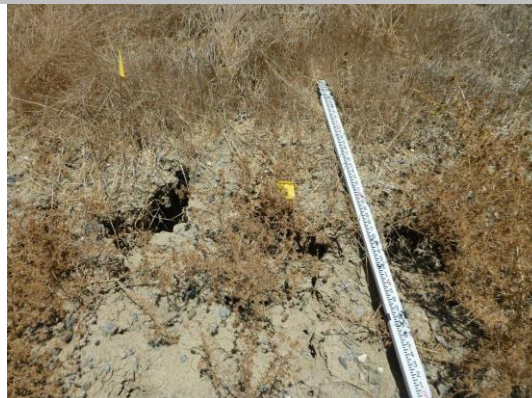
LM Start	47.43	Rating **	A/W	Issue No.	126
LM End	47.53	Issue Type +	Ob	Location *	
Category	Supplemental			GPS Latitude/Longitude	
				Start	End
Item	2017 Storm Damage			39.191283 °	39.192405 °
				-121.986205 °	-121.987320 °
DWR ID	DWR_NA0016_01_f_2017_126				
Comment Code					
Inspector Comment					
Levee Evaluation Comments					
Description:					
Site ID No:187					
Site Designation:SRWLD-05					
Repair Type: Seepage					
Rating:Area of Concern					
Field Date:7/14/2017					
Notes: Berm on LS levee slope will be replaced this season.

LM Start	47.43	Rating **	A/W	Issue No.	126 (cont)
LM End	47.53	Issue Type +	Ob	Location *	
Category	Supplemental			GPS Latitude/Longitude	
				Start	End
Item	2017 Storm Damage			39.191283 °	39.192405 °
				-121.986205 °	-121.987320 °
DWR ID	DWR_NA0016_01_f _ 2017_126				
Comment Code					
Inspector Comment					
Levee Evaluation Comments					
Description:					
Site ID No:187					
Site Designation:SRWLD-05					
Repair Type: Seepage					
Rating:Area of Concern					
Field Date:7/14/2017					
Notes: Berm on LS levee slope will be replaced this season.

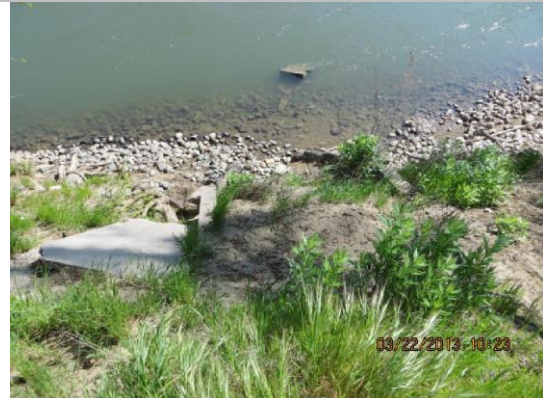
Photo 1 of 2 : UCIP_FA_2018_10563_17941.jpg

LM Start	47.71	Rating **	M	Issue No.	1604	
LM End	47.71	Issue Type +	En	Location *		
Category	Supplemental			GPS Latitude/Longitude		
				Start	End	
Item	DWR UCIP Field Study			39.194772 °	39.194772 °	
				-121.988886 °	-121.988886 °	
DWR ID	20309					
Comment Code						
Inspector Comment						
FS_ID:10563 DS_ID:20309 EP_NO: 9347 Repair Type: Non-Urgent Crossing Status: Indicator Found UCIP Comments: Need to determine type of abandonment. FIELD_STRUCT_DESC: *REMOVED* 2 of 2: 16-inch steel irrigation pipe through the levee, 17.3 feet below the crown. Gate valve on the waterside (WS) end. Pump on the WS bank. Switch box on the WS shoulder. (Automatic Board Order (ABO) issued as Permit No. 9347, 1974 - Floremon Orchards). [Additional Reference(s): DWR Levee Log, 1980. USACE Sacramento O&M Manual 131, May 1960 (HLM 48.23)]. FS Date: 3/22/2013

Concrete pumphouse debris on WS berm.

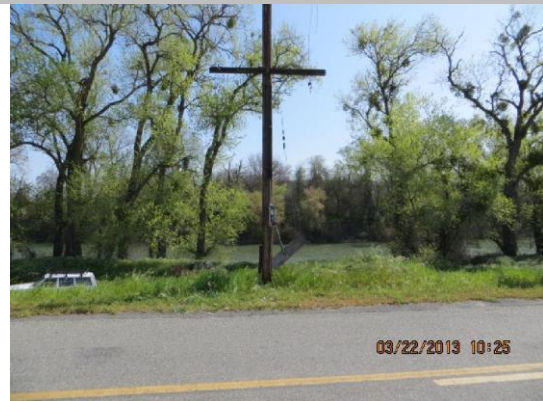
Photo 2 of 2 : UCIP_FA_2018_10563_17940.jpg

JP on WS shoulder for removed pump switch house.

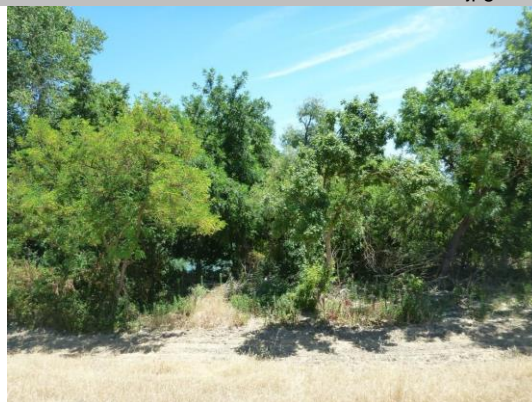
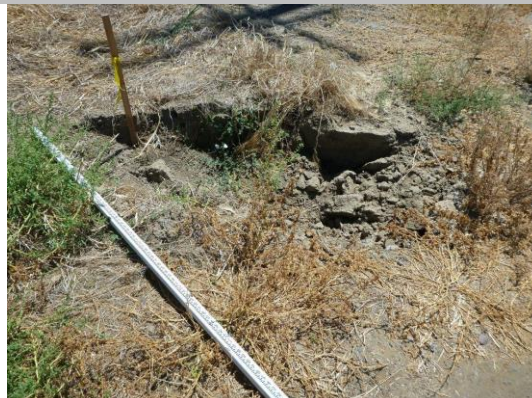
LM Start	47.96	Rating **	A/W	Issue No.	127
LM End	48.03	Issue Type +	Ob	Location *	
Category	Supplemental		GPS Latitude/Longitude		
			Start	End	
Item	2017 Storm Damage		39.198380°	39.199330°	
			-121.988603°	-121.988197°	
DWR ID	DWR_NA0016_01_f_2017_127				
Comment Code					
Inspector Comment					
Levee Evaluation Comments Description: Site ID No:186 Site Designation:SRWLD-04 Repair Type: Seepage Rating:Serious Field Date:7/14/2017 Notes: Berm will be constructed this season.

LM Start	47.96	Rating **	A/W	Issue No.	127 (cont)
LM End	48.03	Issue Type +	Ob	Location *	
Category	Supplemental			GPS Latitude/Longitude	
				Start	End
Item	2017 Storm Damage			39.198380 °	39.199330 °
				-121.988603 °	-121.988197 °
DWR ID	DWR_NA0016_01_f _ 2017_127				
Comment Code					
Inspector Comment					
Levee Evaluation Comments					
Description:					
Site ID No:186					
Site Designation:SRWLD-04					
Repair Type: Seepage					
Rating:Serious					
Field Date:7/14/2017					
Notes: Berm will be constructed this season.

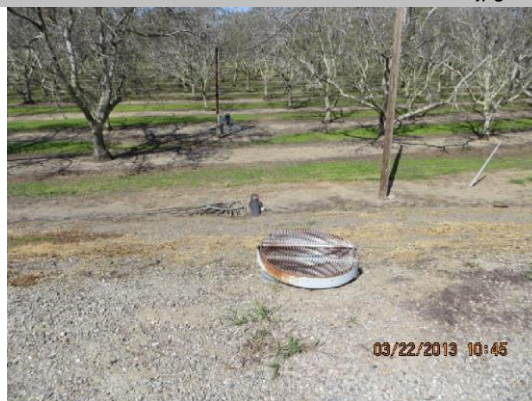
Photo 1 of 3 : UCIP_FA_2018_10566_17954.jpg

Comment Code					
Inspector Comment					
FS_ID:10566					
DS_ID:20300					
EP_NO: 9343					
Repair Type: Non-Urgent					
Crossing Status: Found					
UCIP Comments: Pipe appears to be abandoned. Need to verify type of abandonment.					
FIELD_STRUCT_DESC: 2 of 2: 24-inch irrigation pipe of an unknown material through the levee, 15.5 feet below the crown. (Pipe measures 12 inches on landside (LS) toe). Slant pump on steel piling structure on the waterside (WS) bank. Butterfly valve at the LS toe. Overhead power line crosses the levee. (Automatic Board Order (ABO) issued as Permit No. 9343, 1974 - Emile F. Cribari). [Additional Reference(s): DWR Levee Log, 2006. USACE Sacramento O&M Manual 131, May 1960 (HLM 48.91)].					
FS Date: 3/22/2013

Siphon Breaker in 30-inch CMP riser on LS shoulder and butterfly valve at LS toe.

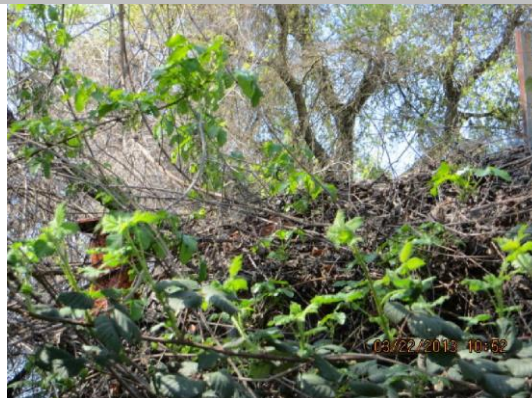
Photo 3 of 3 : UCIP_FA_2018_10566_17952.jpg

Comment Code					
Inspector Comment					
FS_ID:10566					
DS_ID:20300					
EP_NO: 9343					
Repair Type: Non-Urgent					
Crossing Status: Found					
UCIP Comments: Pipe appears to be abandoned. Need to verify type of abandonment.					
FIELD_STRUCT_DESC: 2 of 2: 24-inch irrigation pipe of an unknown material through the levee, 15.5 feet below the crown. (Pipe measures 12 inches on landside (LS) toe). Slant pump on steel piling structure on the waterside (WS) bank. Butterfly valve at the LS toe. Overhead power line crosses the levee. (Automatic Board Order (ABO) issued as Permit No. 9343, 1974 - Emile F. Cribari). [Additional Reference(s): DWR Levee Log, 2006. USACE Sacramento O&M Manual 131, May 1960 (HLM 48.91)].					
FS Date: 3/22/2013

Pump on structure covered in brush on WS berm.

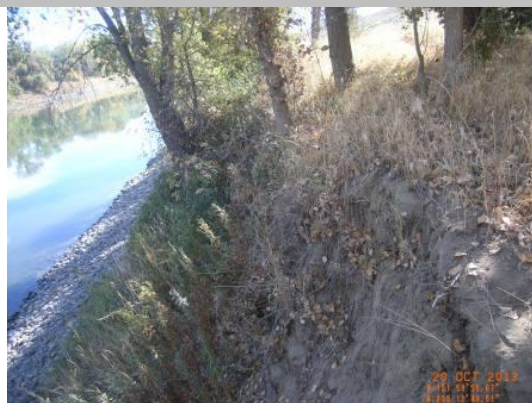
Photo 1 of 1 : FA_2018_NA0016_435_105_20181023_00240.jpg

LM Start	49.46	Rating **	A/W	Issue No.	105
LM End	49.57	Issue Type +	Ma	Location *	WS
Category	Supplemental			GPS Latitude/Longitude	
				Start	End
Item	2017 USACE Erosion Survey, DRAFT			39.213608 °	39.213869 °
				-121.997543 °	-121.999641 °
DWR ID	DWR_NA0016_01_f _ 2018_105				
Comment Code					
Inspector Comment					
2017 Site ID: SAC 143.5 R Status: Eroding 2017 Field Notes: New erosion along lower slope. Site History: 2011 - Multiple scallops, one tree pop out. Old cobble site starting to unravel at midbank. 2012 - Mid bank slumping continues to worsen but cobble at the toe appears stable.					
DWR Inspector Comment: Erosion on the waterside berm. Recommend monitoring.
